# WIND DAMAGE ON LOW SLOPE ROOFS FROM HURRICANE KATRINA

By Cheri Panasik, PhD and André Desjarlais

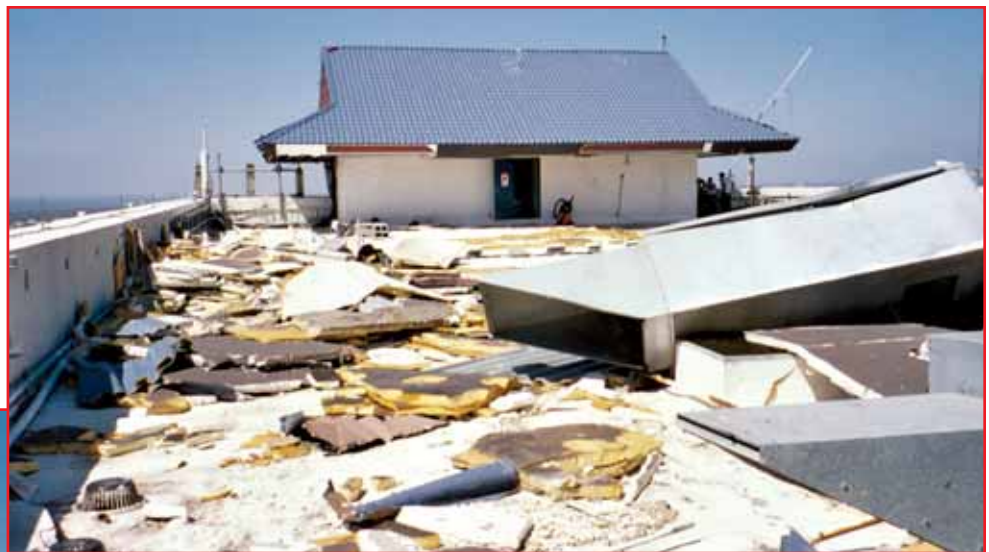
*Photos 1 and 2 –  
Impact of reduced  
fastening patterns.*

The investigation team inspected several types of low-slope roofs, such as SPF, SBS, BUR, and metal. The team found some of the same issues as seen in previous hurricane investigations. Some damaged membrane and edge details were not secured according to standard fastening pattern guidelines. An extreme example of this issue was found on a waterfront hotel in Biloxi, Mississippi. The SPF roof was only five years old and blew off during Hurricane

Katrina; however, the fastening pattern used did not match any prescribed method (see Photos 1 and 2).

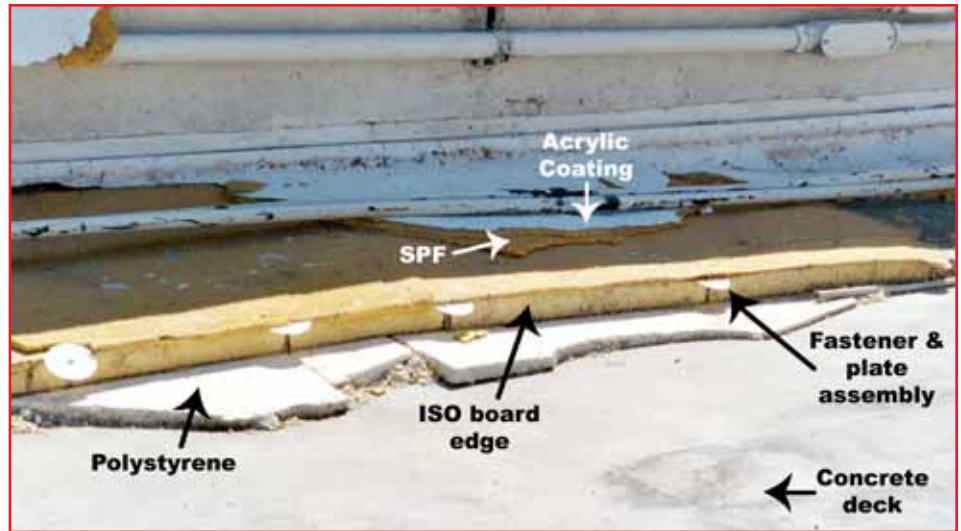
Photo 3 – Cross sectional view of roof system.

The SPF roof system of a 350-foot-tall waterfront hotel in Biloxi, Mississippi, consisted of a white acrylic coating; 1/2-inch-thick, 4-ft by 8-ft ISO insulation; and expanded polystyrene fastened to cast-in-place concrete using screw anchors (Photo 3). Three screws with plastic roofing plates were used to fasten each 4-ft x 8-ft board and the rest of the required fasteners were

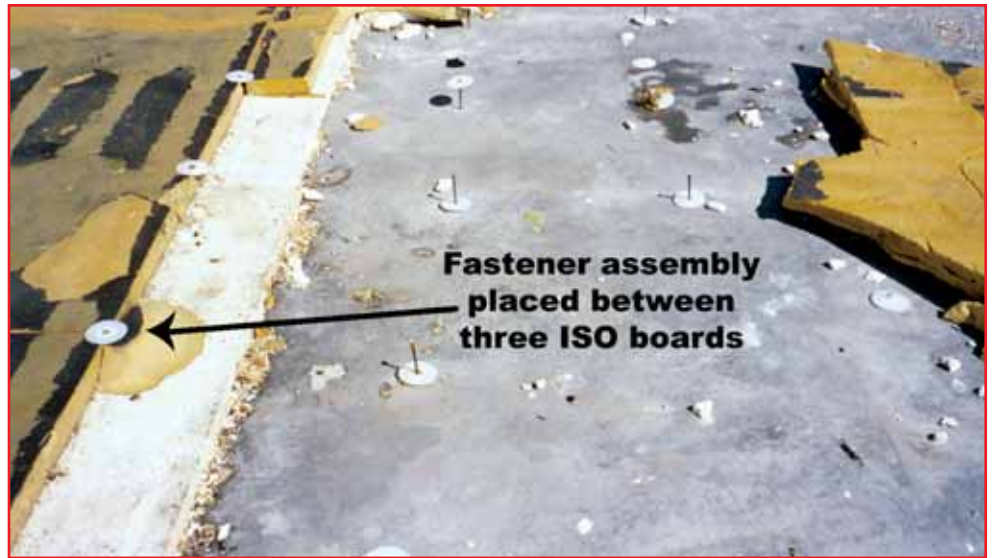
not installed (*Photo 4*). Additional fasteners were placed between each 4 x 8 board, thus not following any prescribed fastening pattern. The corner of each board was secured by fasteners that were installed between the board corners with the plastic plate straddling three ISO boards (see *Photo 5*).

Insulation fastening should be installed a minimum of six inches from the edge of the insulation board and never shared between boards. Perhaps an inspection by a qualified inspector during roof construction could have detected and stopped such a fastening pattern. As a result of the fastening mistakes, over 50% of the roof was blown off, leaving only the screws and plates secured to the concrete deck.

*Photo 5 – Fasteners were driven between ISO sheets, shared by adjacent boards.*

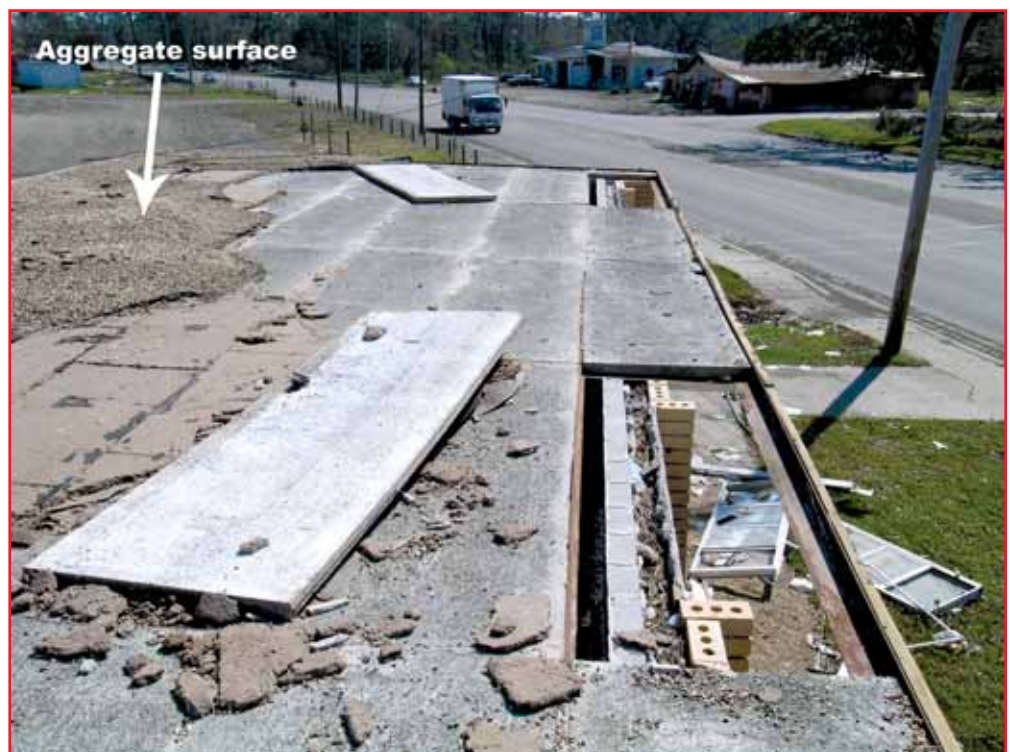
Several BUR systems performed well; however, the BUR and windows of a middle school building built in 1959 located in Di’lberville, Mississippi, were unable to resist the hurricane. Ninety-five percent membrane damage and complete window blow-out allowed massive content damage. The membrane was a four-ply system with aggregate surfacing (*Photo 7*). It was mechanically attached with split-shank, sheet-metal barb nails in a three-per-square-foot fastening pattern in the perimeter zone. The roof deck was cementitious wood fiber and was secured to steel joists using sheet metal H clips fastened every eight feet on center.

Twenty-five percent of the edge nailer was detached. The system attachment substrate had 90% damage. Deck movement occurred in the southeast corner. The deck was detached from the secondary support.

The sheet-metal H clips were corroded and pulled out of place from the steel bar joists. The base sheet split nail fasteners pulled out. The base sheet, membrane, and deck panels detached from the roof as uplift

*Photo 7 – This four-ply, aggregate-surfaced, BUR system suffered 95% membrane damage.*

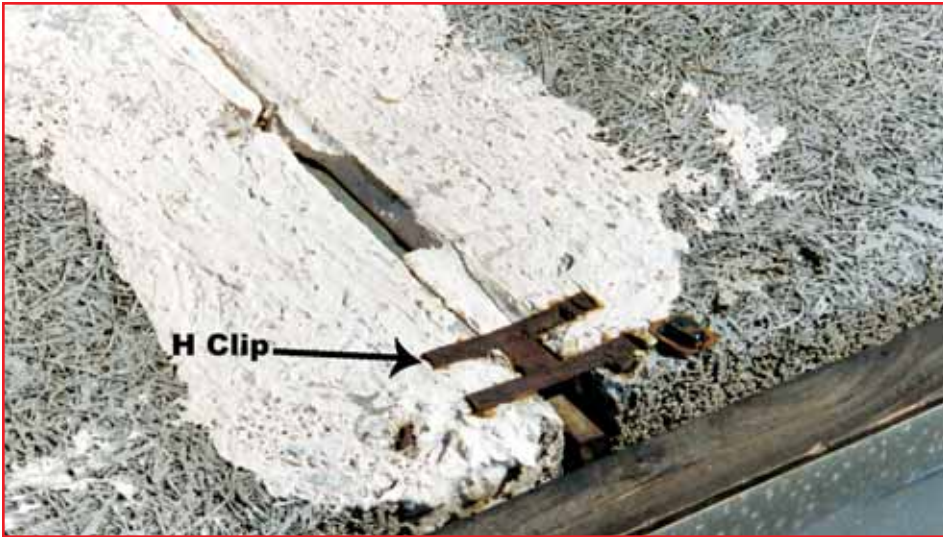
forces pulled H clips out of the steel joists. The remaining H clips were easy to lift and remove from the steel joists, thus not providing resistance to uplift forces (*Photo 8*). Numerous roof deck panels were displaced.

*Photo 8 – The sheet metal H clips were corroded and easily pulled out of the steel joists, providing insufficient resistance to wind uplift forces.*

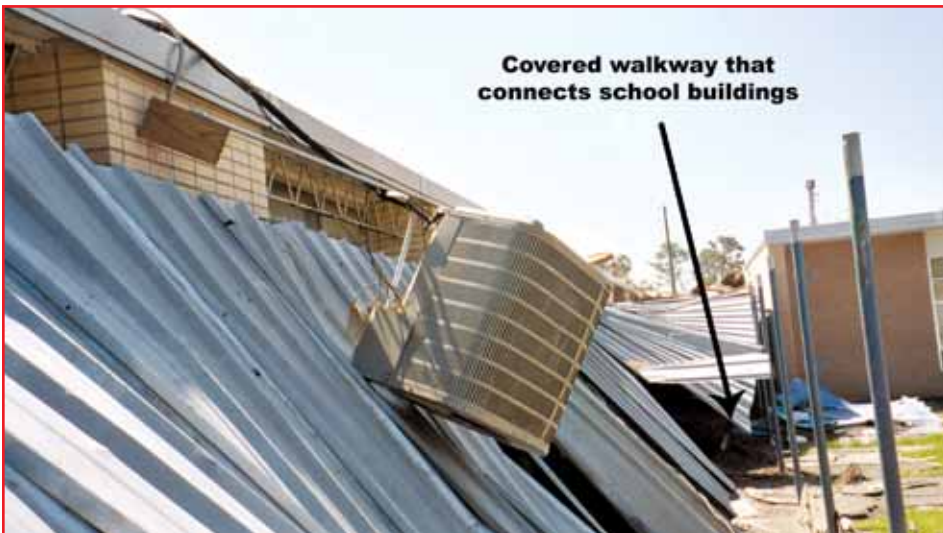
A roof-mounted air conditioning system landed on a covered walkway (*Photo 9*). Developing and following a prescribed method to secure such units to the roof could reduce damage from this equipment during high winds. The inside of the building and its contents were destroyed.

*Photo 9 – A roof-mounted air conditioning system landed on a covered walkway.*
